**BINDURA UNIVERSITY OF SCIENCE EDUCATION  
DEPARTMENT OF NATURAL RESOURCES**

**A STUDY ON PHYSIOCHEMICAL ASSESSMENT OF GROUNDWATER. AT  
POMONA LANDFILL HARARE.**

***A DISSERTATION SUBMITTED IN PARTIAL FULFILMENT OF REQUIREMENTS OF THE  
BACHELOR OF SCIENCE HONOURS DEGREE IN NATURAL RESOURCES MANAGEMENT***

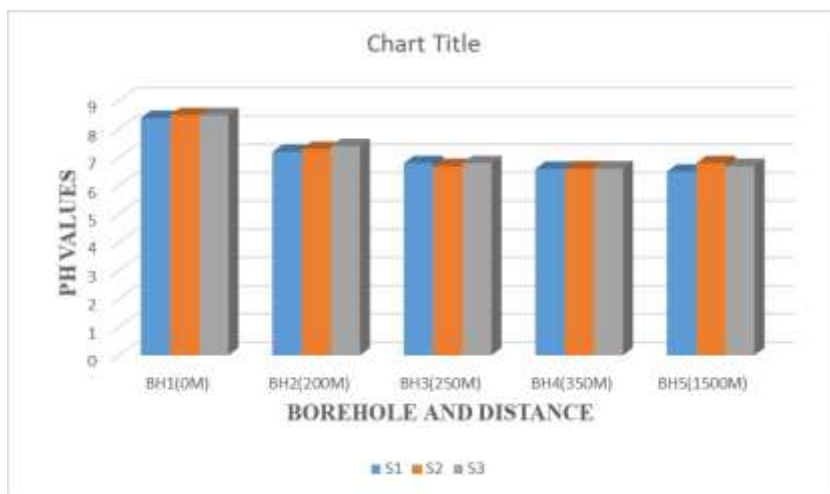
**Figure 4.1 ;PH variations between boreholes within and outside pomona dump site**

The pH showed clear trend across the borehole (figure 4.1).The pH range from 6.5 up to 8.5.PH levels decreased from alkaline to normal with distance from the pomona landfill .BH1(0m) within the landfill has higher range of pH and BH4 and 5(control ) recorded the lower pH level(figure 4.1).

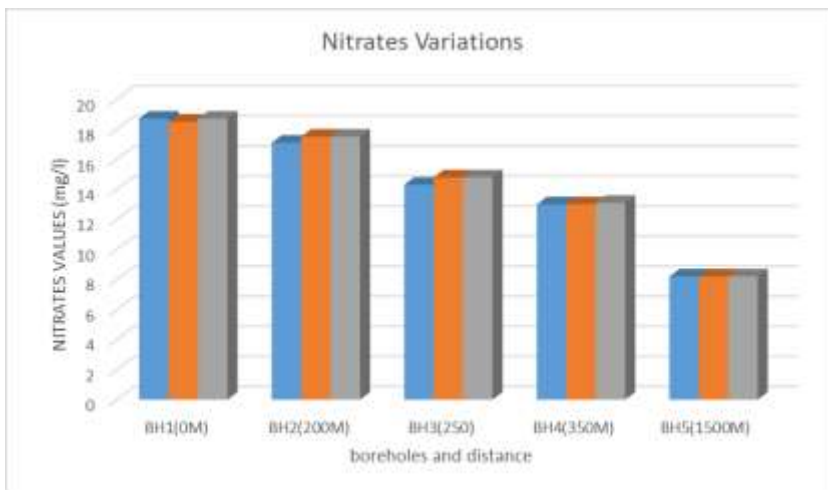
**Figure 4.2 Nitrates variations between boreholes within compared to boreholes outside Pomona landfill**

Nitrates was higher in the borehole 1 within the landfill ranged 18.7mg/l (figure 4.2). It then decreased in boreholes outside the landfill with the lower nitrates ranged 8.2 in the control borehole 5 (1500m) (figure 4.2).

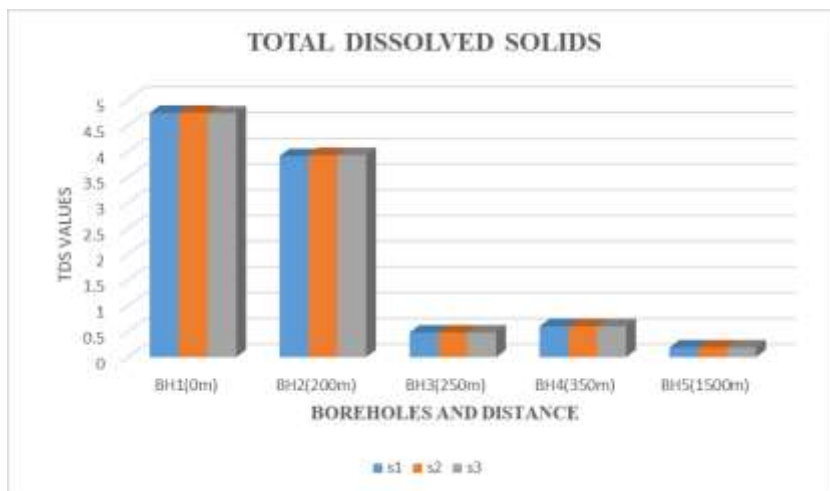
**Figure 4.3 Total Dissolved Solids variations between boreholes within and outside the pomona dumpsite**

Total dissolved solids were also higher in borehole 1(00.m) as shown (figure 4.3).Concentration of tds was lower in the control borehole(1500m) and it increases as the distance as one approaches the borehole near the landfill (figure 4.3)

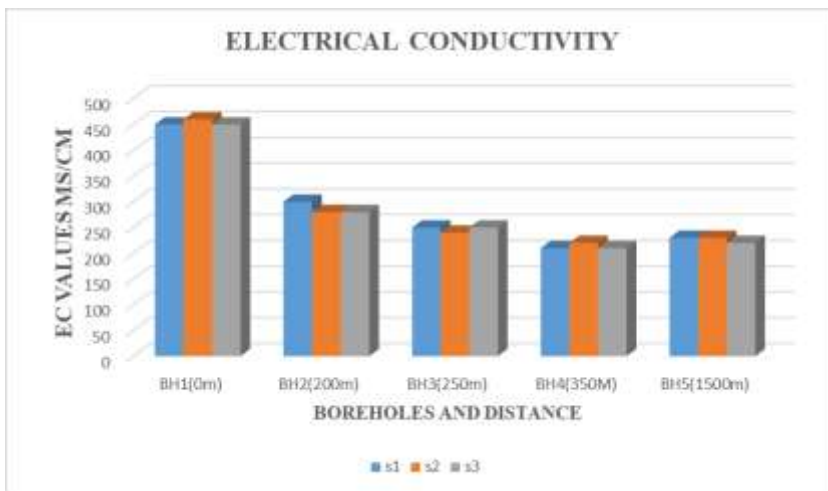
Figure 4.4 Electrical conductivity variations in boreholes within compared to boreholes outside pomona landfill

Conductivity was lower in borehole 4 (350m) with an average of 213ms/cm .It then increase by two times from borehole 4 (350m) to 450ms/cm to the borehole within the landfill (figure 4.4).

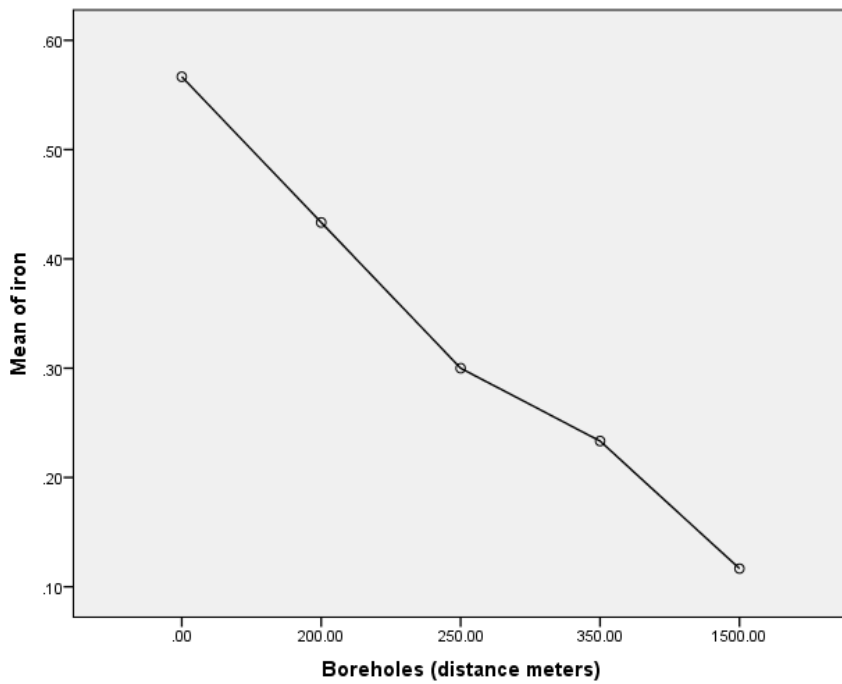
**Figure 4.5 Iron variations in boreholes within the dumpsite compared to boreholes outside the Pomona dumpsite**

Iron concentration was also lower in the control borehole (1500m) with an average of 0.11mg/l (figure 4.5) .

Borehole 1 (00m) within the landfill had higher concentration in iron (0.57mg/l) (figure 4.5) .Iron concentrations as shown on the graph decreased as distance from the landfill increased (figure 4,5)

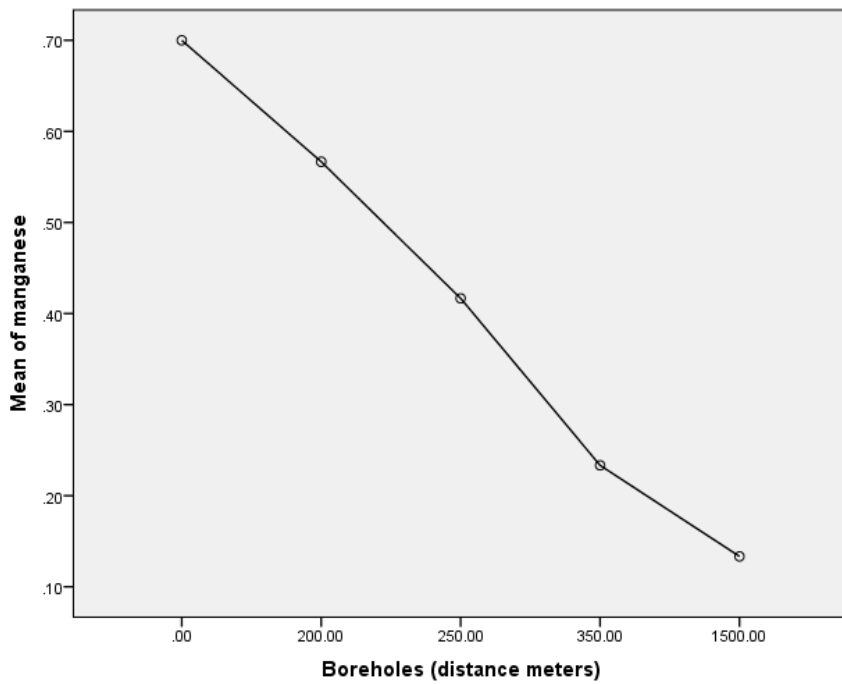
**Figure 4.6 ;Manganese variations in boreholes within the landfill compared to boreholes outside the pomona dumpsite**

Manganese concentration was higher in borehole 1(00m) within the landfill with an average of 0.7mg/l.It then decreased as distance increased from the landfill(figure4.6).Also the control borehole (1500m) had lower average of 0.13m/l .There was a sharp decrease in manganese concentrations from borehole (00m) within the landfill to all the boreholes outside the landfill (figure 4.6)

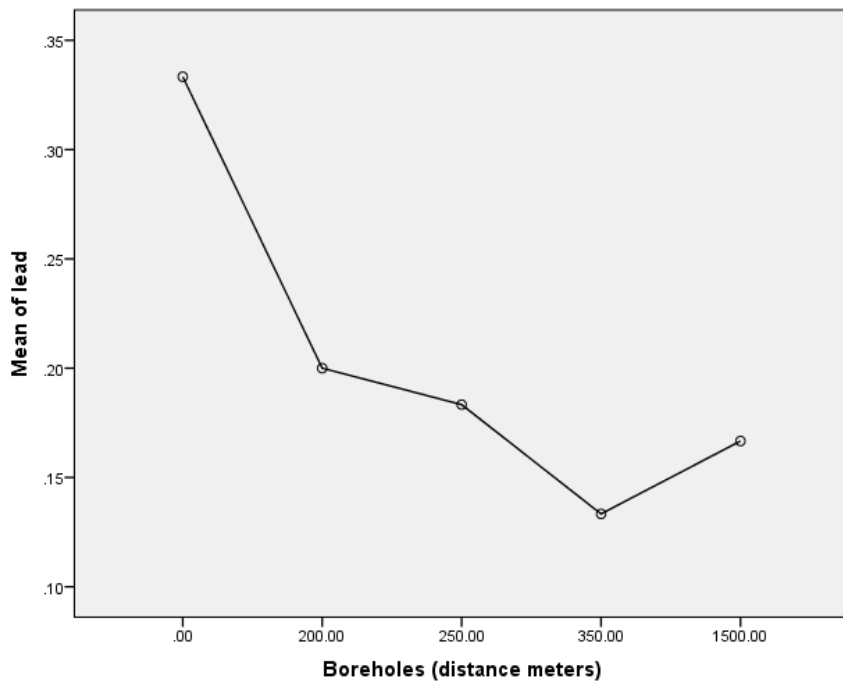
**Figure 4.7 ;Lead variations in boreholes within the pomona landfill compared to boreholes outside the pomona landfill**

Low concentration in lead was recorded in borehole 4(350m) outside the pomona landfill with an average of 0.13mg/l (figure 4.7) .The concentration increased as distance close to the landfill , with the borehole within recorded an average of 0.33mg/l which was the highest (figure 4.7).
